ROAD 27 BRIDGE CONSTRUCTION & REPAIR

Joe Hedges, CHSRA
Ghassan Ariqat, TPZP
John Corven, Corven Engineering, Inc.

September 9, 2020

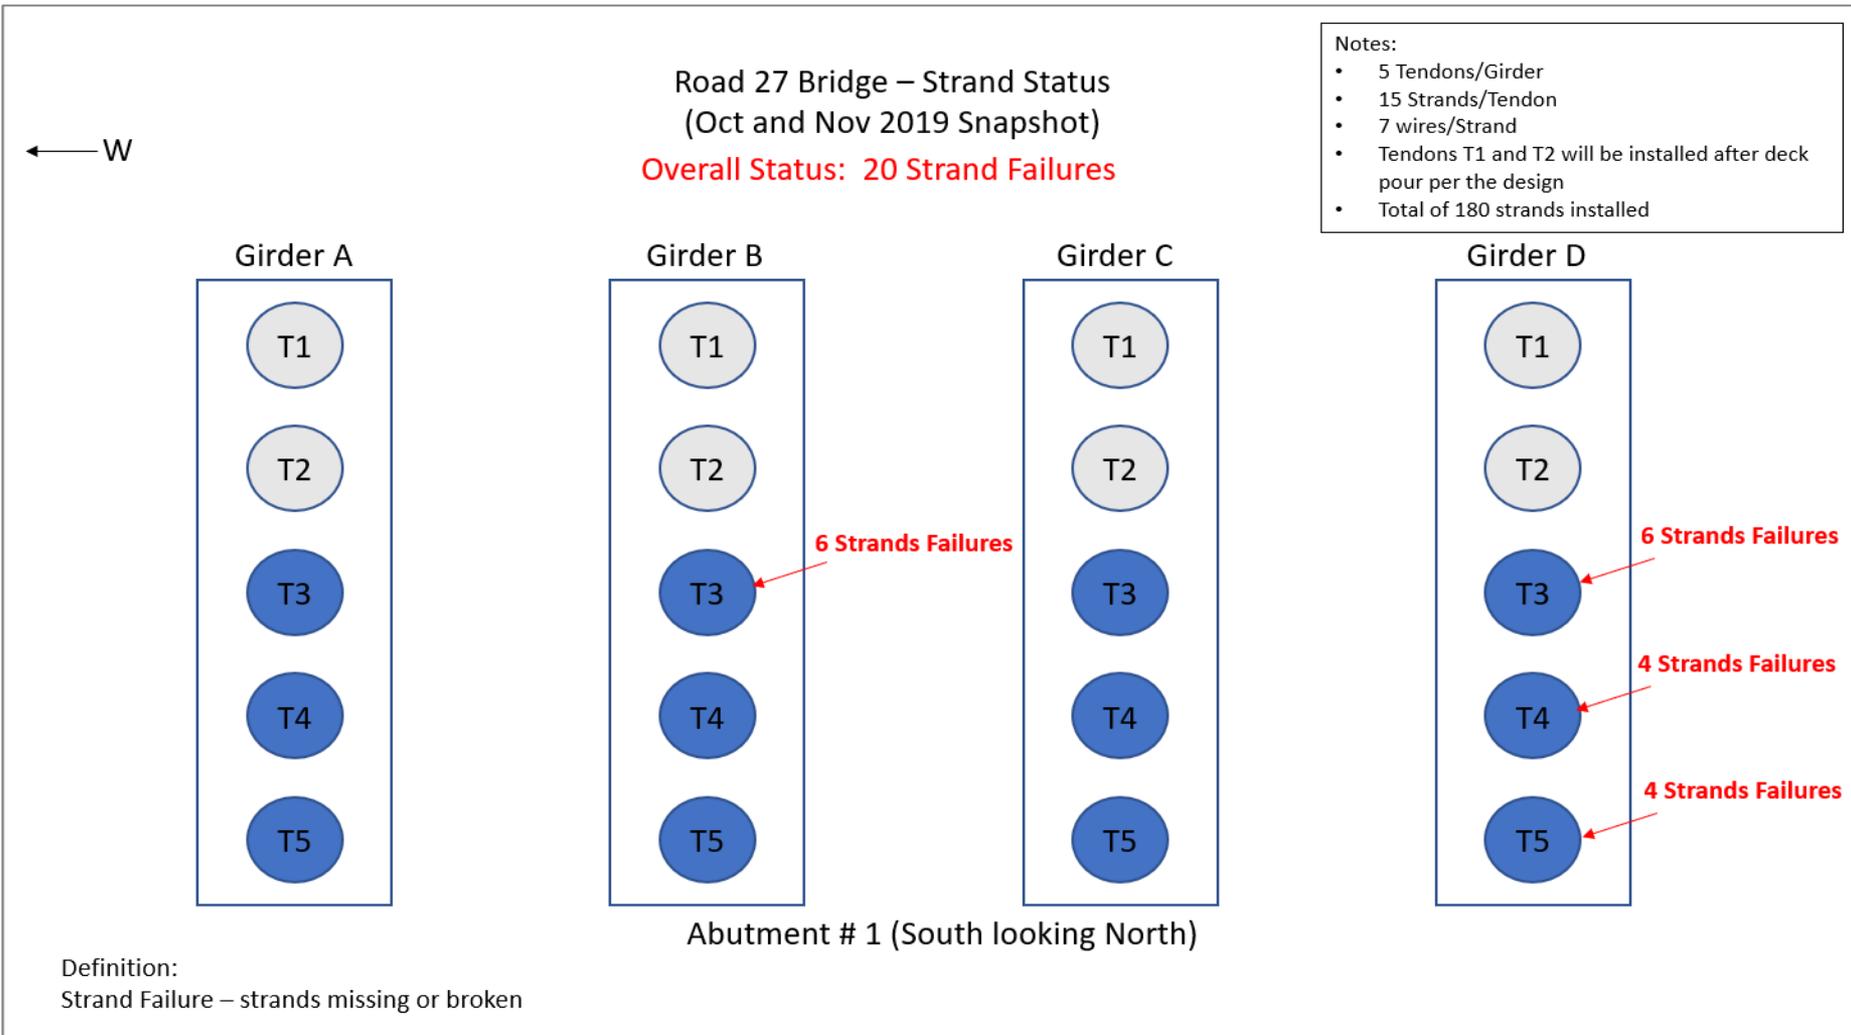
INITIAL STRAND FAILURES

Replaced November & January 2020

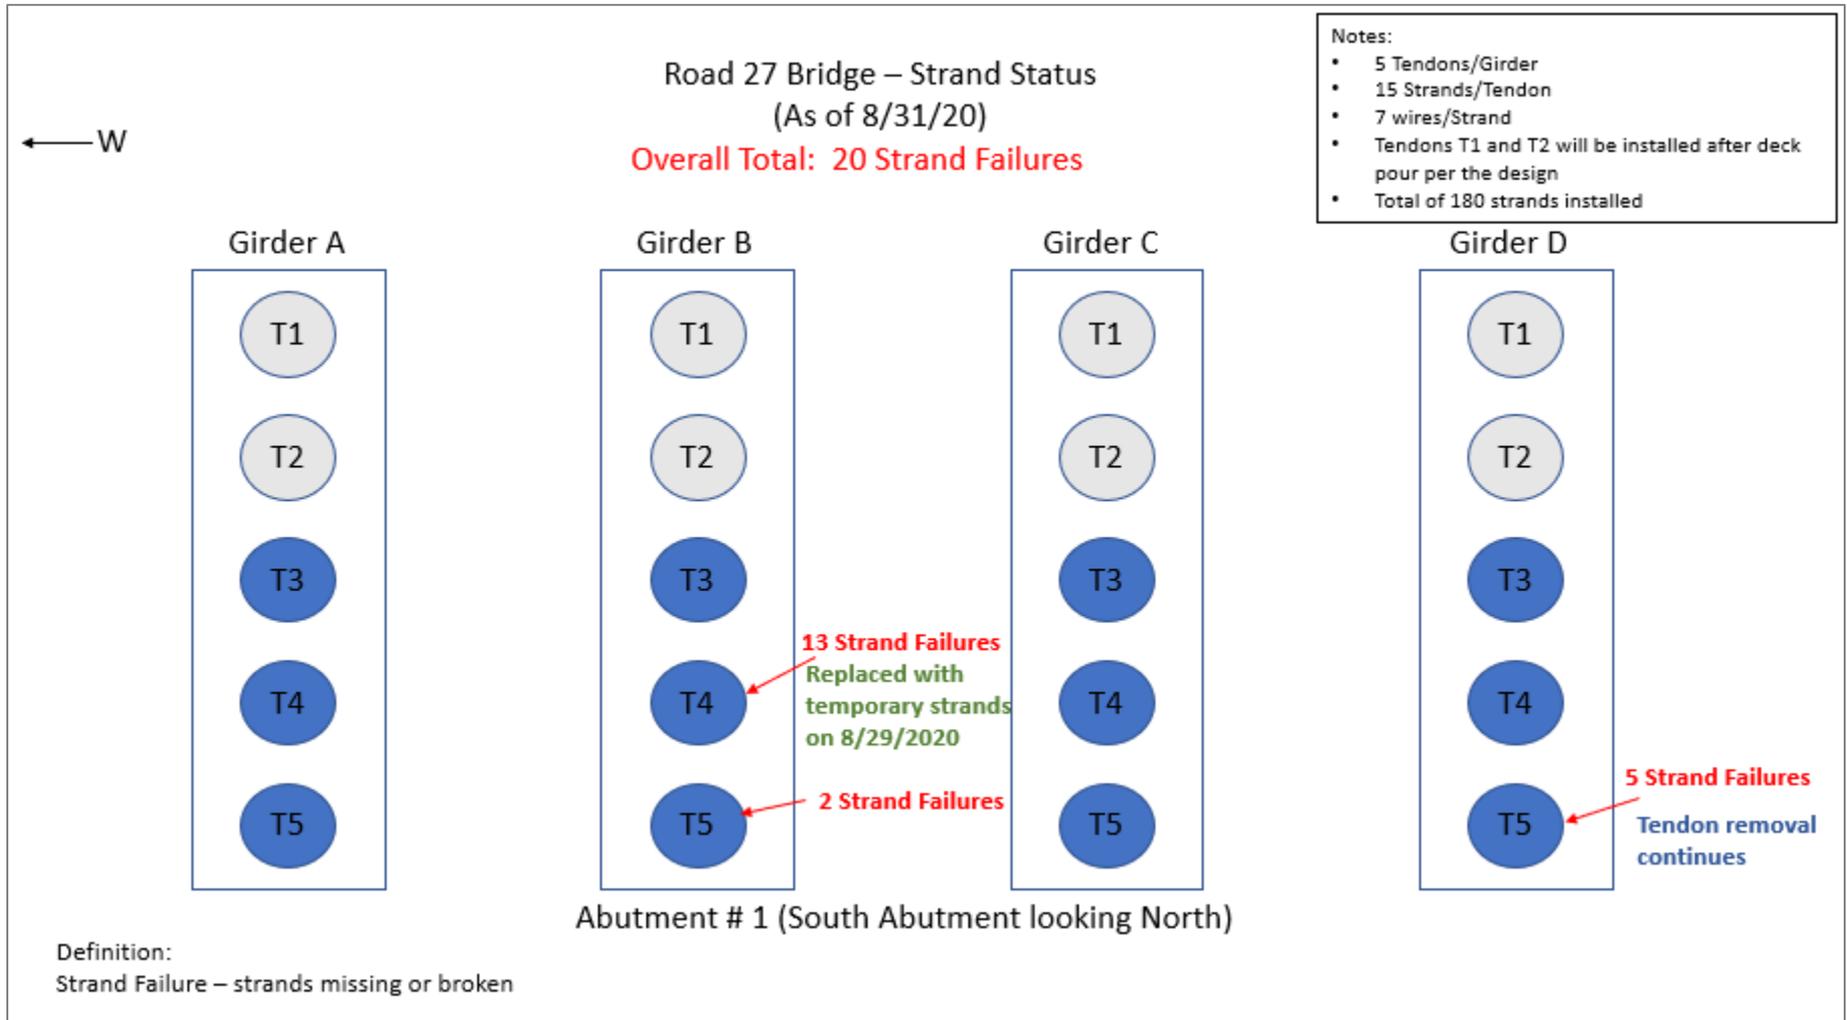
ADDITIONAL STRAND FAILURES - AUGUST

Investigation Underway

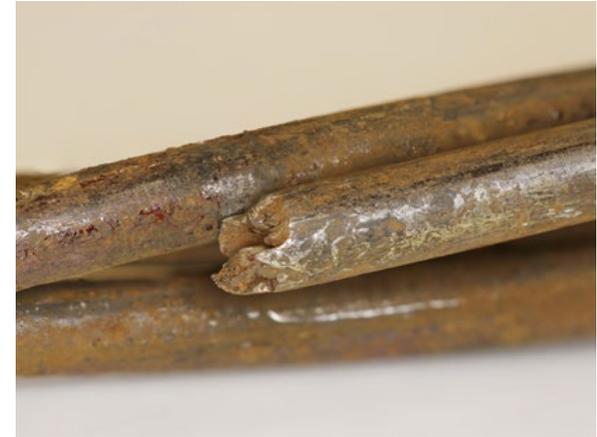
- » Water made its way into the post-tensioning ducts through broken vent tubes, which led to the corrosion of the affected strands.

- » Long term presence of moisture in the ducts after the tendons were stressed

Corroded Strands

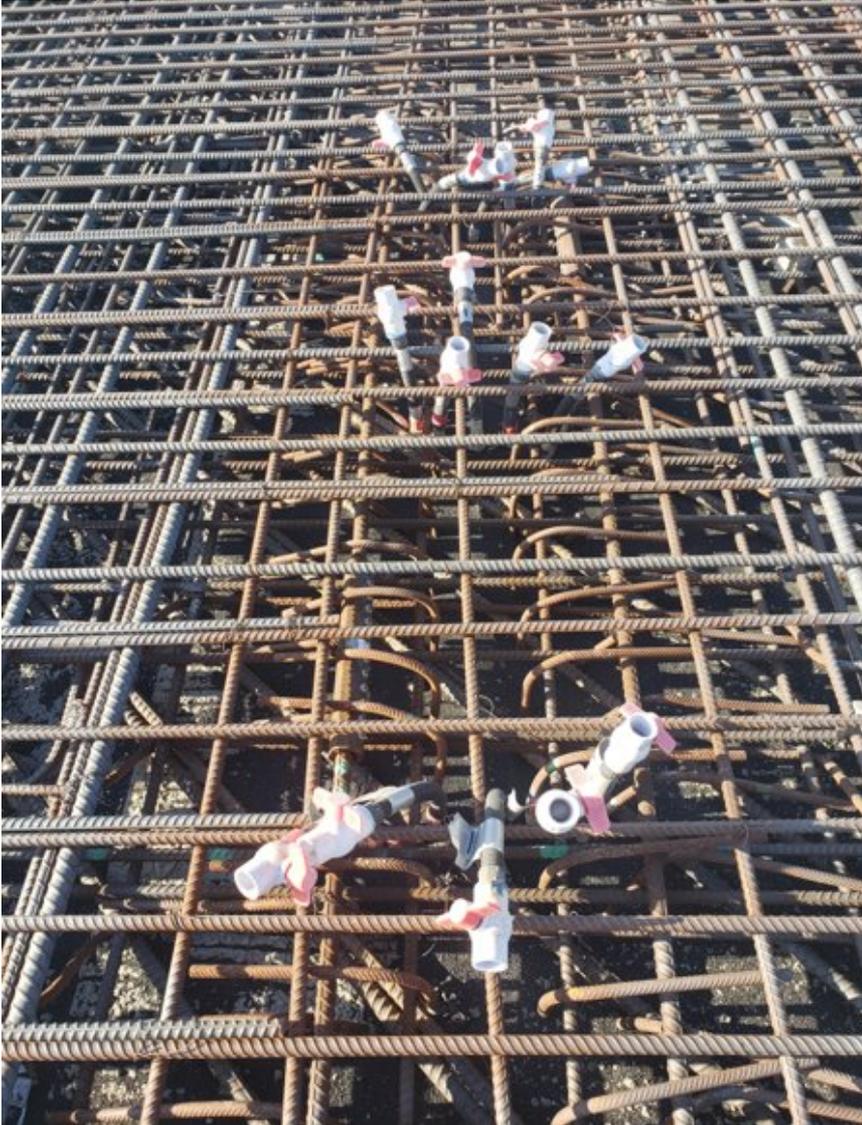
VENT TUBES ON DECK

- Connected to the Tendon Ducts
- Support the grouting of the tendons in the ducts by allowing air to escape as the duct is injected with grout.
- Are the likely access for water entrance that facilitated the corrosion of the post tensioning strands
