ROAD 27 OVERCROSSING PROGRESS UPDATE

November 30, 2020

CURRENT STATUS

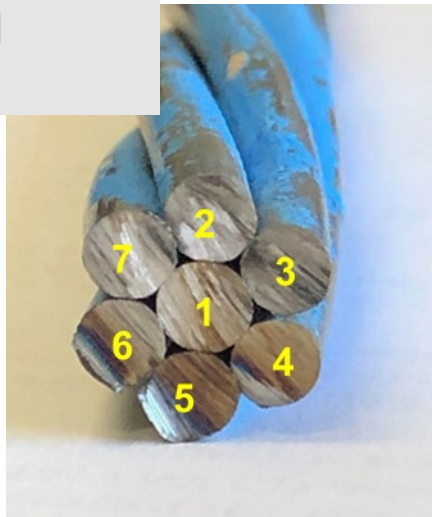
- 7 wires per strand

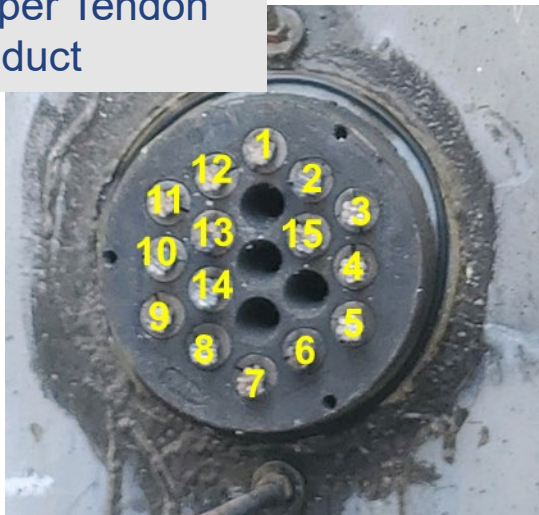
- 15-strands per Tendon
- Tendons in duct

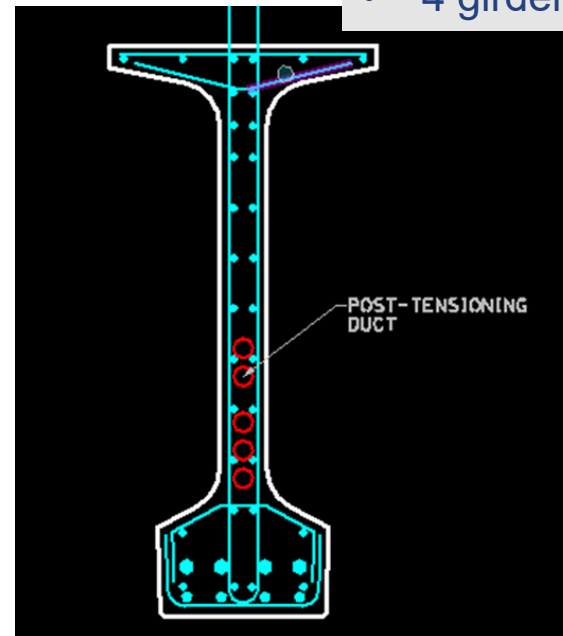
- 5 tendons per Girder
- 4 girders for the bridge

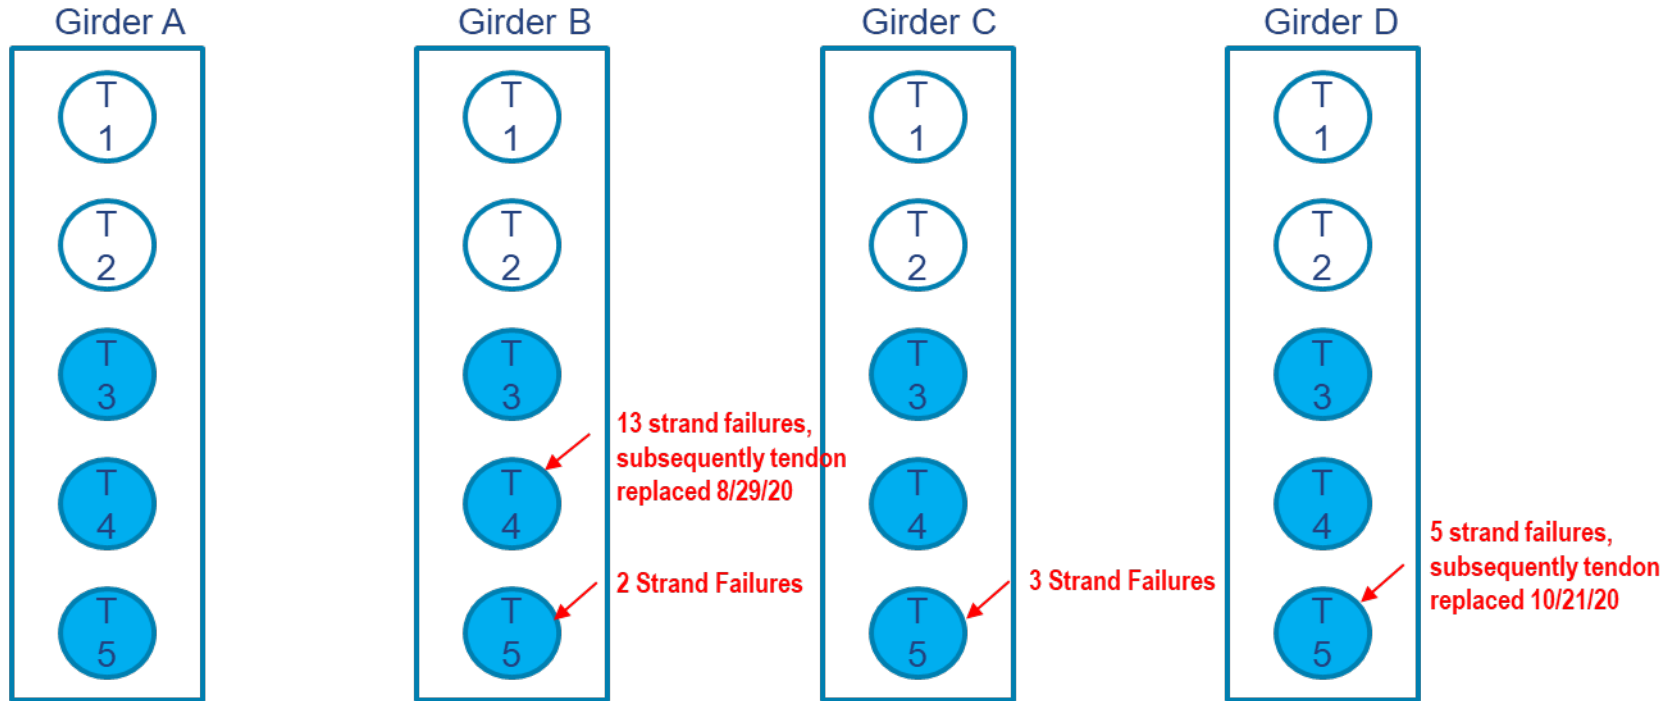
Abutment # 1 (South Abutment looking North)

- 23 strand failures 8/13/20 – 12/01/20

● Tendons installed and tensioned

○ Tendons to be installed and tensioned after deck placement

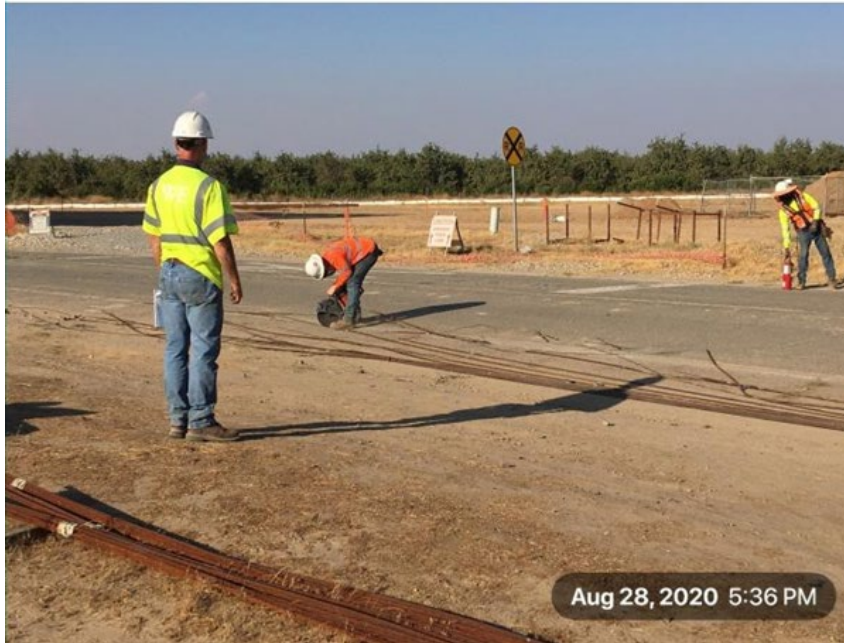
Removal of strands for tagging and inspection from WJE

- ✓ Daily strand checks
- ✓ Removed and replaced broken strands in girders B4 and D5
- ✓ Performed further analysis to verify root cause
- ✓ Identified/verified source of water intrusion and sealed ducts
- ✓ Full-time on-site superintendent and quality inspector assigned during all repair work
- ✓ Additional independent expert analysis of additional damaged strands

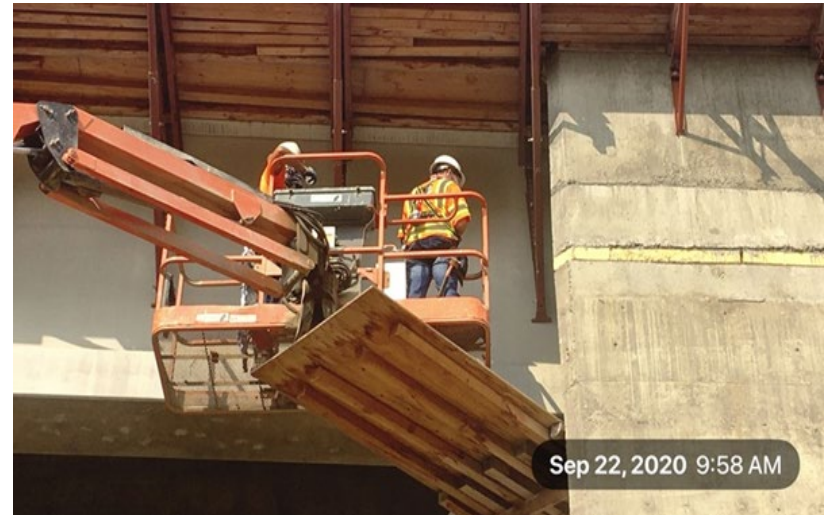
California High Speed Rail Authority & PCM performing ongoing bridge inspection for Road 27
